THE ROYAL BELL

The historic building and current condition

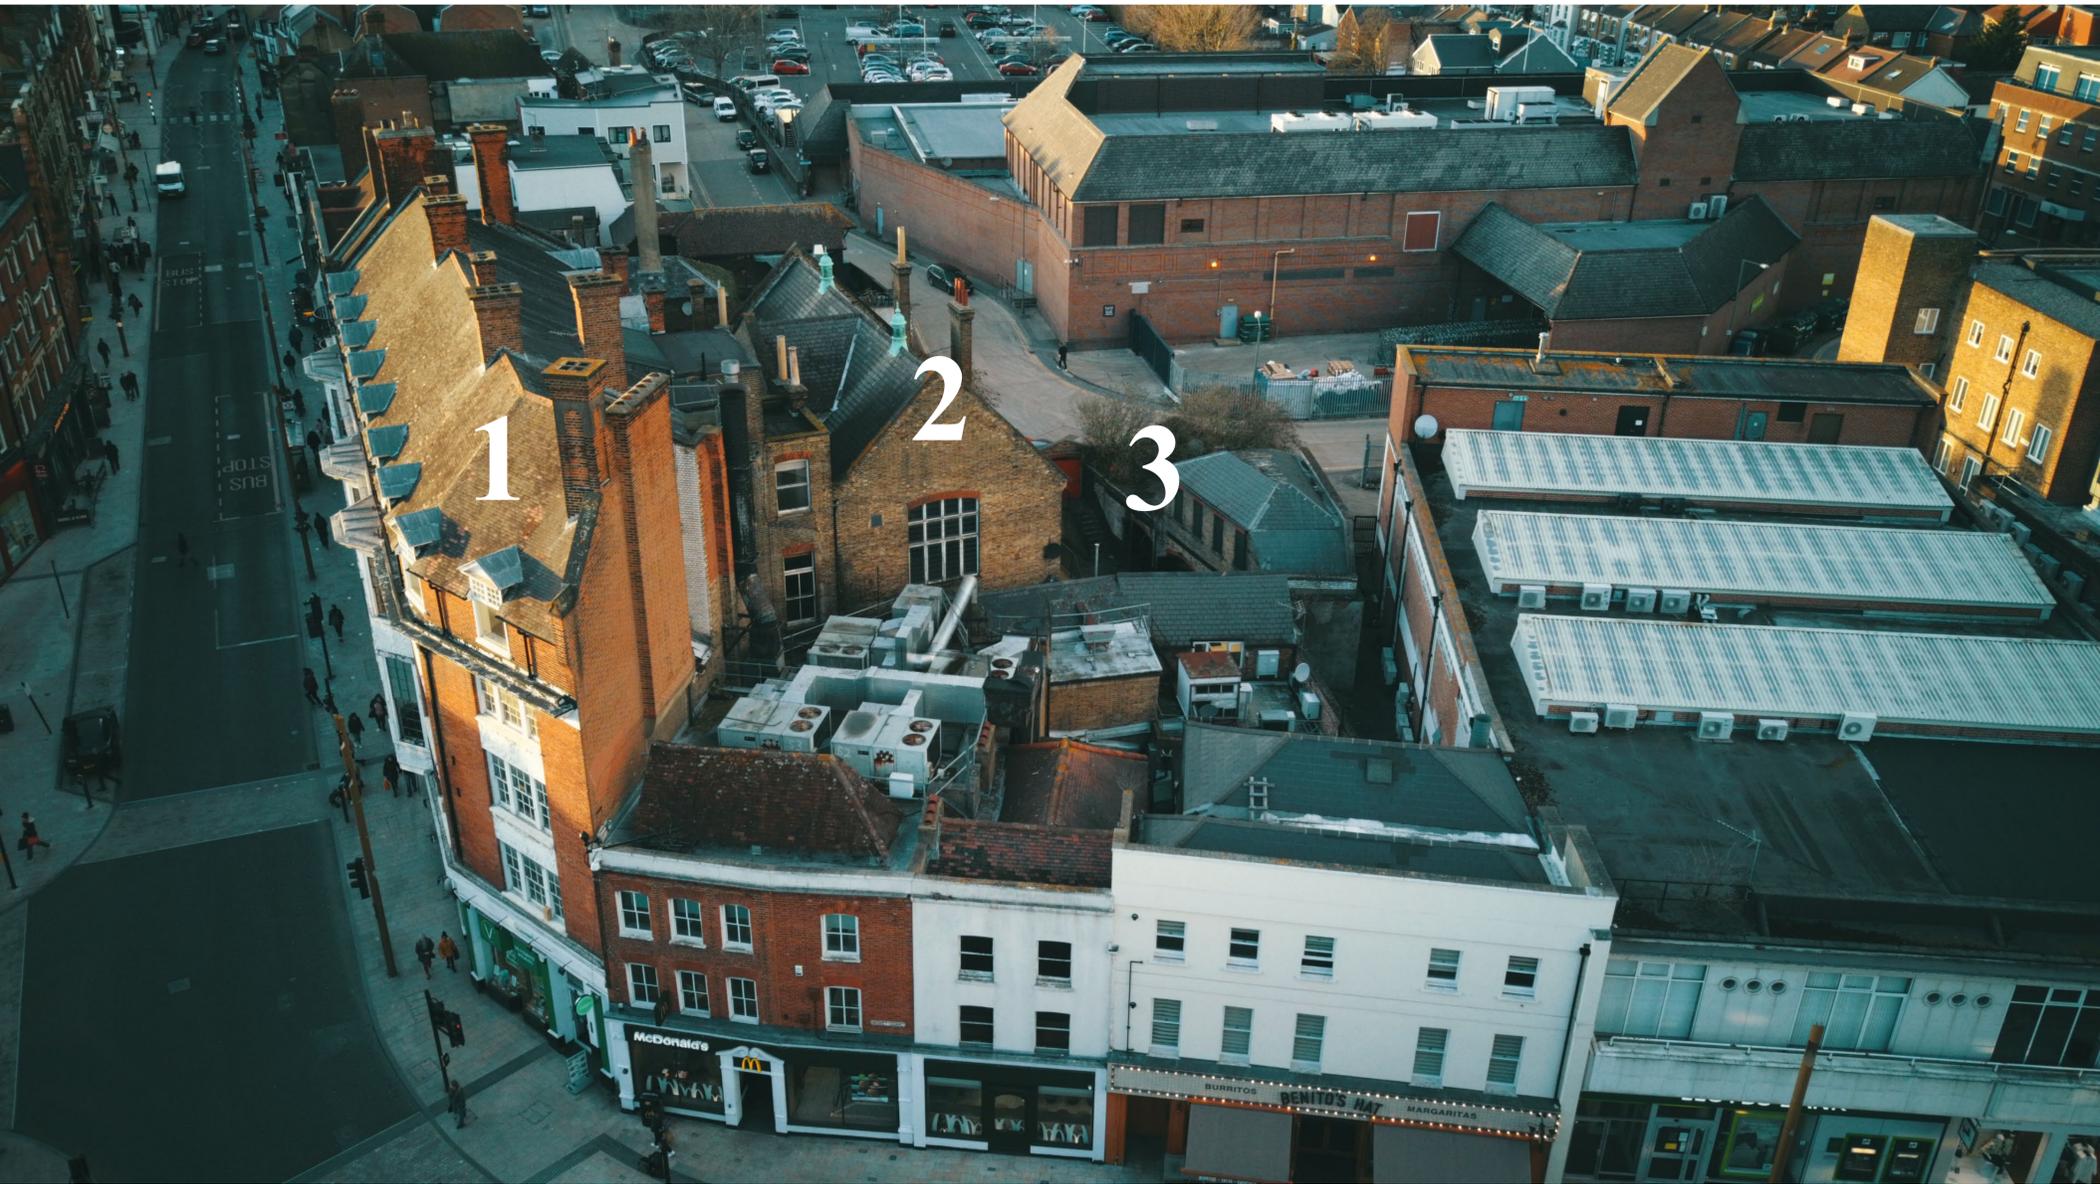
1. Main Building

This range was rebuilt in 1898 on the site of the earlier hotel of 1666. The architect Ernest Newton specified these high status red bricks for this frontage with a traditional red 'Wrotham' tiled roof. Iconic features of this facade include the large painted timber modillion cornice, the three double height projecting window bays with decorative pargetting, the classical granite entrance surround and intricate historic iron gates to the carriage passage.

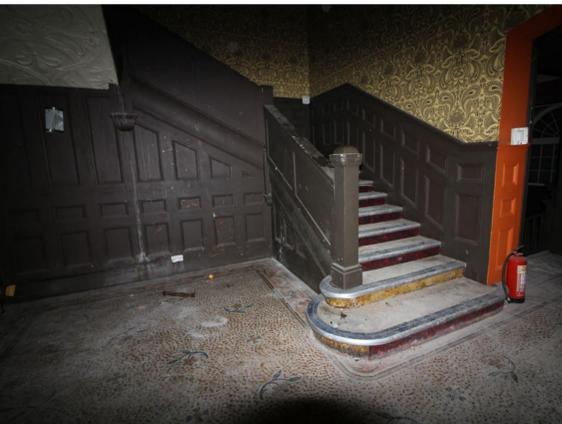
The original main staircase survives at The Royal Bell. We propose the careful repair and restoration of this grand stair and the detailed balustrade which survives behind modern boarding. Also visible in this image is the intricate glass mosaic floor to the lobby. This is to be carefully cleaned and restored to its former glory.

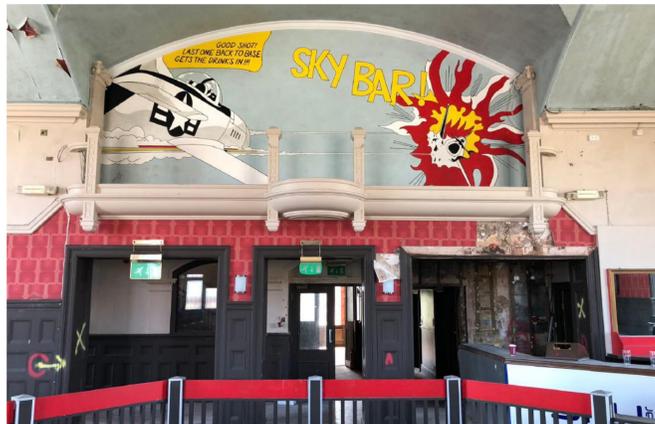
This internal view of the ballroom shows the boarded up minstrel's gallery and projecting balcony. We would like to re-instate the lost balustrade and re-open the gallery as a heritage feature. Also visible in this image is the railing of a large void in the floor which was created in recent years. We propose that the ballroom is restored to its original design and that the missing floor is reinstated.

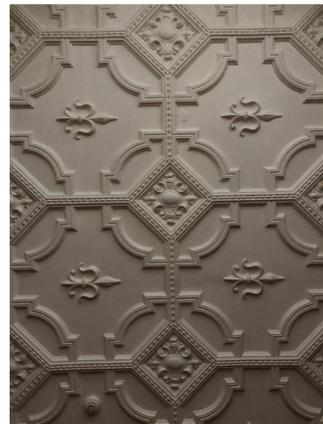
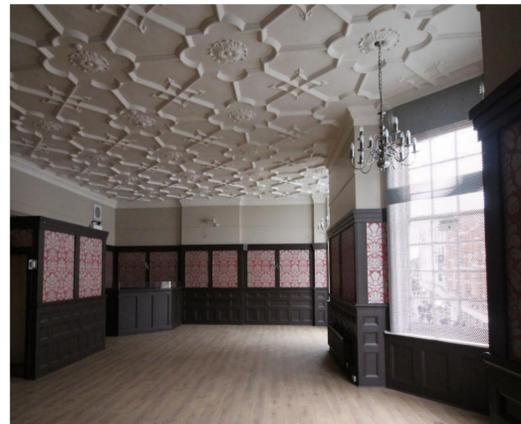
These photographs were taken in the main function room to the front of the building at first floor level. The ornate plasterwork to the ceiling survives in its entirety in this space and forms one of the key heritage assets of this building. This bright and light filled space has fantastic views over the historic heart of Bromley.

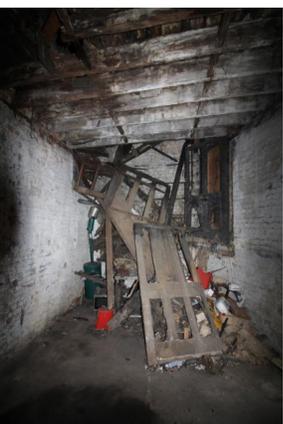
A fire in recent years has seriously damaged parts of the stable and hayloft.

A passage from the high street leads to a yard at the rear of the site. Historically this would have been the route used by horse and carriage to access the stabling facilities. The stables are visible in this image to the rear of the yard. A fire in recent years has sadly damaged parts of the stable and hayloft beyond repair. We propose the careful dismantling of the stables and the re-use of this redundant yard area to house a new hotel extension.

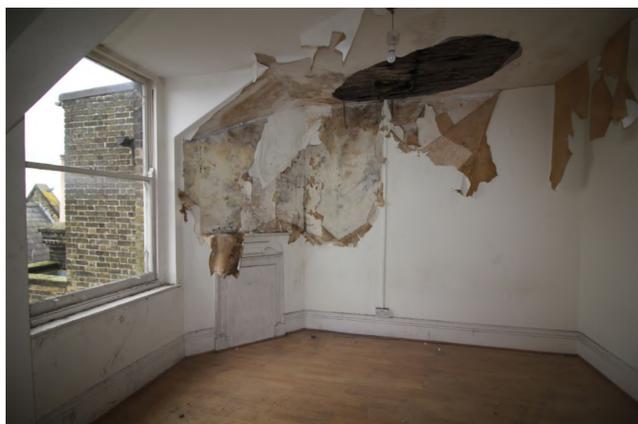
A number of rooms to the third floor have suffered from water ingress from the main roof which is in need of repair. Luckily many of these rooms still feature the original cast iron fire surrounds.

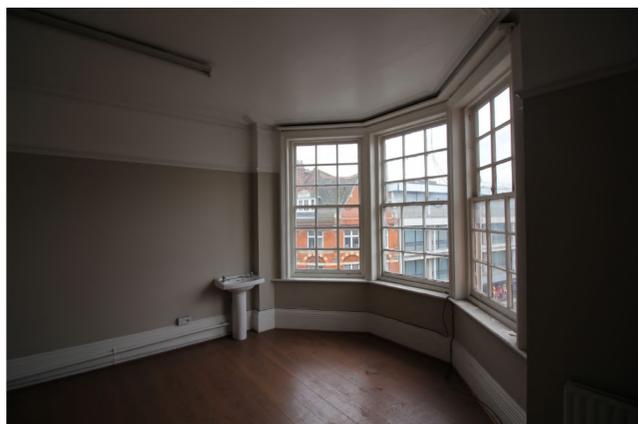
This photo shows one of the second floor rooms to the front of the main building. Our proposal shows these rooms carefully and sympathetically transformed into hotel bedrooms in keeping with the original use of these spaces.

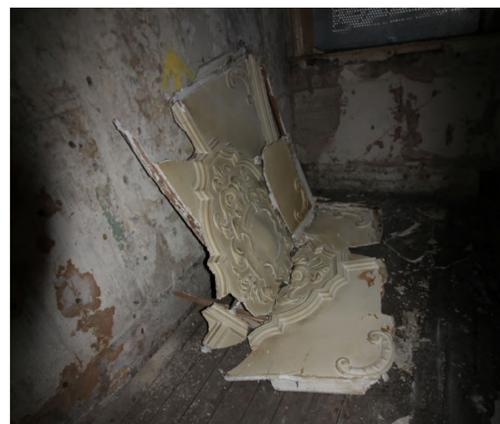
A fallen section of ornate plasterwork lays in the boarded up minstrel's gallery which once overlooked the Ballroom. We would like to restore and re-open this gallery as a heritage feature of the hotel and Ballroom.
